PAST EARTHQUAKES – WHAT HAPPENED LAST TIME?

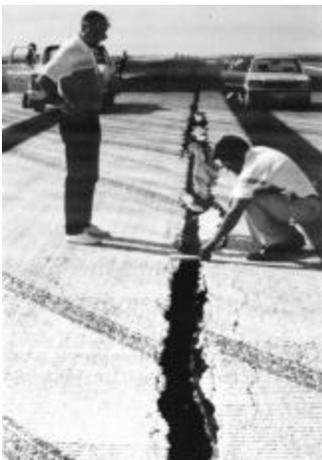
source –
SFO – R. Wiggins

San Francisco International Airport (SFO) was over 35 miles from the fault source for the Loma Prieta earthquake. Although operations at SFO officially halted for one night, this was not due to any significant damage to the facilities or the runways. The control tower sustained window and non-structural damage, and some unanchored equipment was broken, but this did not prevent the tower from operating. ***The primary reason for the shutting down of flights during that night was that not enough controllers were available to operate the tower safely.*** The runways (built on fill), navigational equipment, runway lights, fuel tanks, and piping were mostly unaffected. However, liquefaction (a process where loose water-saturated sands temporarily behave like a liquid when shaken) shifted some small support structures. Lost power was restored within 3 hours, well before the time the airport was reopened. Non-structural damage occurred in the terminals, but did not cause the airport to be shut down. Damage to an air cargo building was significant, and problems transpired with a power transformer, but these were remedied over time without air operations being affected. ***There were no problems with access road failures or freeway closures within the immediate vicinity of this airport that contributed to closure. However the ability of the controllers to travel to work safely and quickly was an issue*** (EERI, 1990).

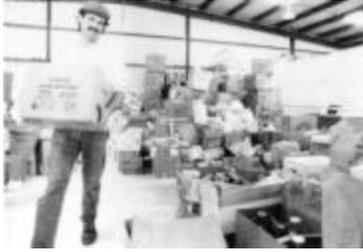
source –
J. Villarin,
for California Pilots Association

The Watsonville airport, with two 4,000-ft. runways, had a loss of power and no emergency generators. Thus, flights could not depart at night due to lack of runway lights. Some hanger doors fell from their support rails. However, this airport became a key player in the emergency relief effort. For example, there was an average of 25 military flights per day. In addition, approximately 300 flights were made by light planes on the weekend of October 28-29 (EERI, 1990). A total of about 300,000 pounds of emergency supplies were flown to Watsonville and Hollister during the week following the earthquake utilizing over a hundred small aircraft (J. White, California Pilots Association, personal communication, 2000).

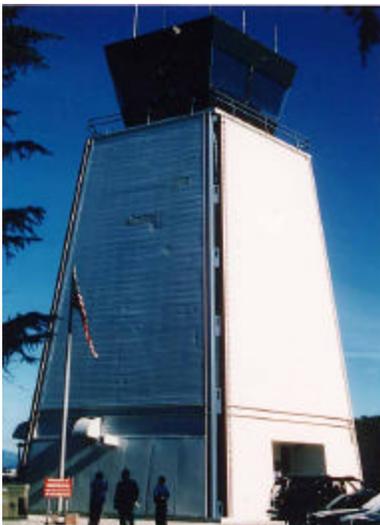
Van Nuys Control Tower had gashes in its siding caused when 3/4" thick windows fell.
source –
A. Schiff, 1995

Van Nuys Airport, the general aviation airport closest to the area of highest shaking intensity, had window glass breakage in the control tower (EERI, 1995a). Equipment in that tower slid up to 4 inches. Damage to FAA facilities at the airport control tower totaled about \$160,000 (Schiff, 1995).
